**DELINEATION OF WETLANDS AT A DEVELOPMENT SITE
IN PANORAMA GARDENS, PIETERMARITZBURG**

Alletson Ecologicals

March 2011

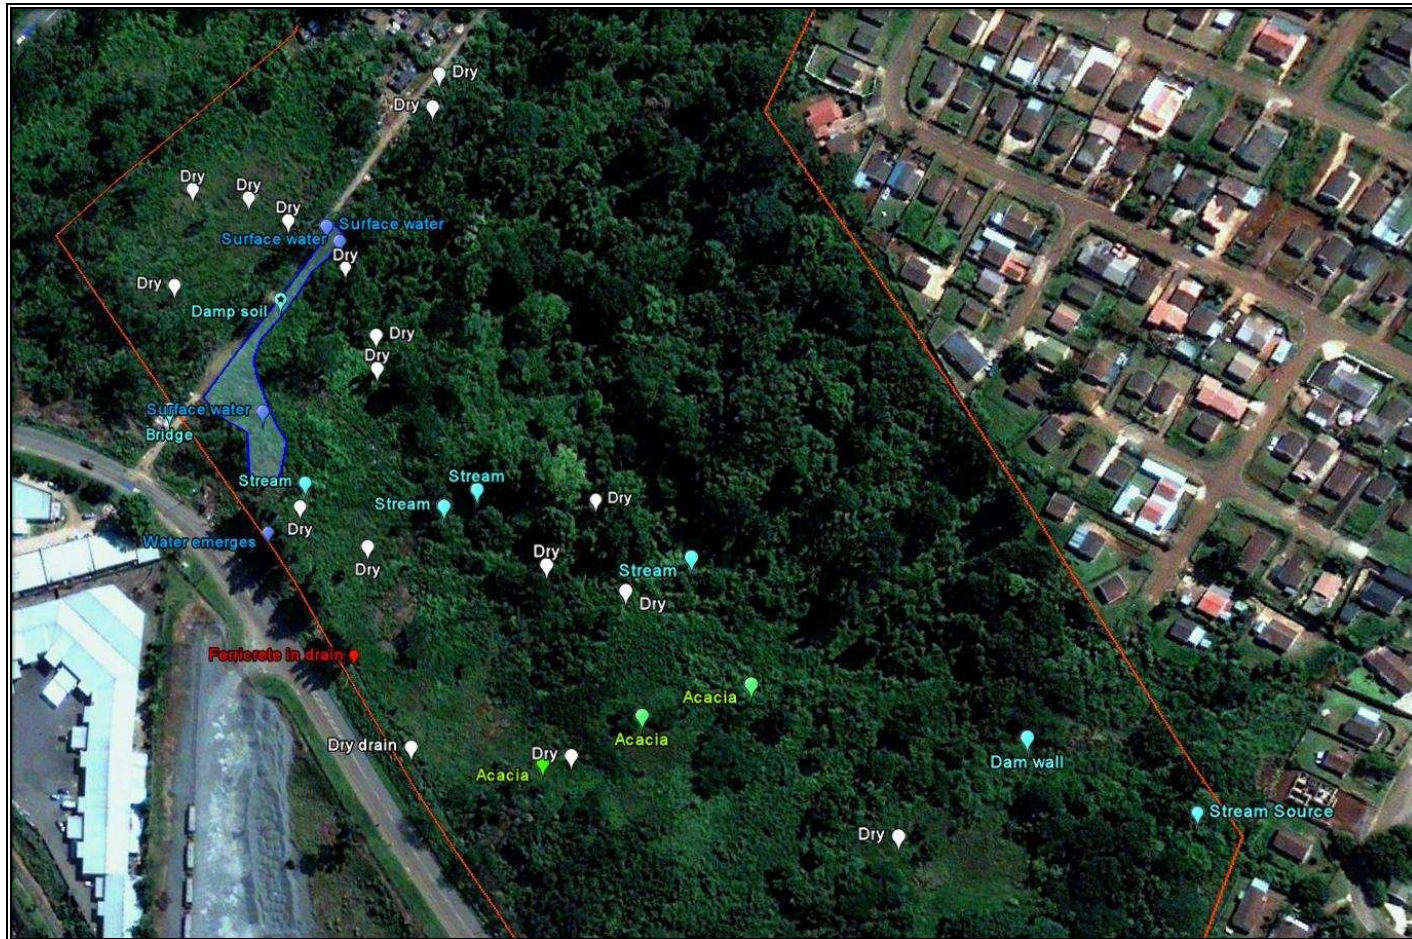
However, surface water, or recent evidence of surface water, was observed in an area close to the point at which the service track from Birmingham Road enters the property, and then for about 85 metres along the track towards the quarry. This water was underlain by heavy soils but the distribution of the soils was restricted to a strip along the eastern side of the track. By contrast the area between the track and the Baynes Spruit, even though it is largely in the 1 in 10 year floodplain (Terratest, 2010), showed neither any wet areas nor any signs of wetness in the soil. It is assumed that development in this area would be restricted due to the presence of the floodplain and so a buffer would incidentally be set in place.

On the basis of the observed stream flows it appears that the small stream which flows from the east side of the property is the primary source of water in the area near the service track. Once its excavated channel flattens out, the water diffuses over a wider area. It is unable to percolate away due to the underlying plinthite layer and so the soils in the area are seasonally saturated. This accounts for the appearance of the water in the drain from the pipeline valve chamber and also explains the observed damp conditions along the eastern side of the track. The track itself appears to be impermeable as it has, over the years, been regularly hardened with road material and so now acts as a “buried dam wall”. Such impermeability also explains the complete absence of wet conditions on the western side of the track.

Figure 2. Portion of the property showing the area along the stream and where wet/moist conditions were encountered. Survey sites are shown in the following colours: White = dry, Light blue = stream or damp conditions, Dark blue = surface water, Green = trees which require dry conditions. Also shown as a blue polygon is the area within which moist conditions were found.

The above observations and deductions indicate that there is a wet area in the corner of the property as indicated in the Msunduzi plan. However, it is much smaller than indicated although the plan may include a buffer area and it cannot be ascertained whether or not the system occurred naturally. In order to allow planning of the site to continue it is necessary to consider how to manage the area to best effect. An earlier report on this subject (Alletson Ecologicals 2010) recommended that the stream channel could be passed into an underground pipe in order to allow it to pass through the area with minimal risk of picking up additional contamination. That report suggested that the water would be unlikely to pick up further pollutants and debris if it were in a pipe and so the quality of the Baynes Spruit would, in view of the proposed industrial development on the site, be best served by this option. To a large extent this proposal is again supported here but with three key modifications which are as follows:
