**DELINEATION OF WETLANDS AT A DEVELOPMENT SITE  
IN PANORAMA GARDENS, PIETERMARITZBURG**

**Alletson Ecologicals**

**March 2011**

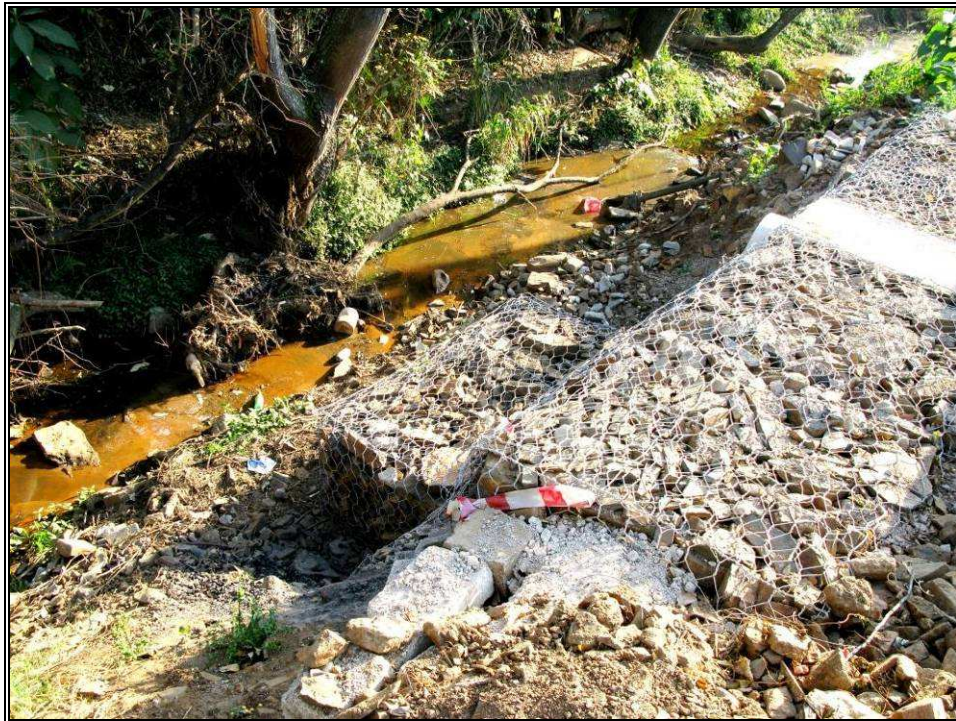
By the time the water leaves the third pond it should be very much cleaner than it was at the top of the property. Thus a useful service will have been provided and, at the same time, habitat for some wildlife will have been retained. This system should be more sustainable in the long term than an open stream through the site. Other such streams in industrial areas, as indicated in the photograph below, tend to become open drains where wastes of many sorts accumulate.

**Photograph 1.** Mkondeni Stream in an industrial area. Note the accumulation of solid wastes in the channel as well as evidence of oil or other such contaminants on the water. The channel is being scoured.

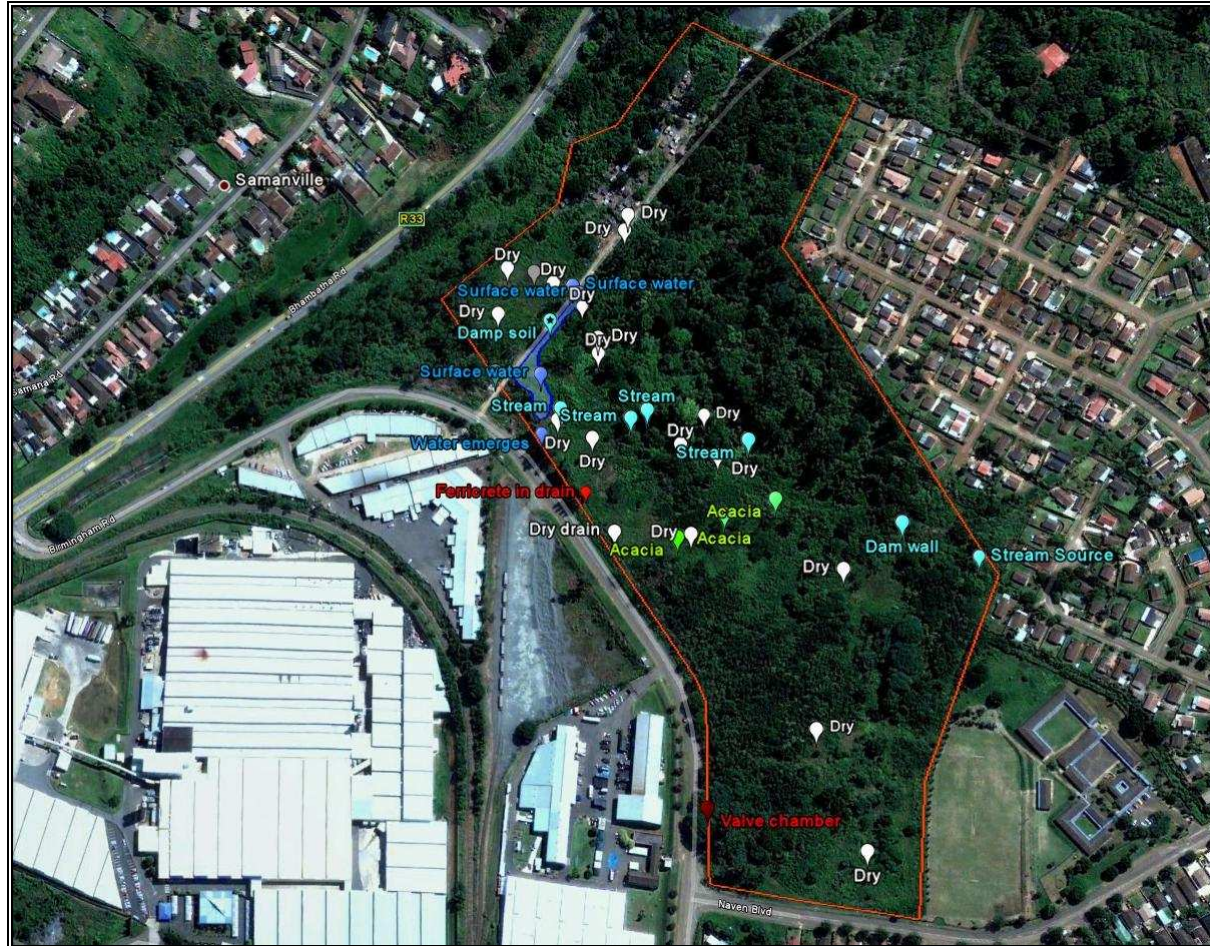
A second, and bigger, drain passes down the entire side of the property adjacent to Birmingham Road. It too appears to be man-made as a heap of the excavated material lies alongside most of its length. Its origin seems to be close to a valve chamber on a pipeline and it is probable that its prime function is to carry off water released when the pipe is scoured or undergoes some similar management activity. The flows can be quite strong as is shown by erosion in the channel and, in places, all the soil above a ferritic plinthite stratum has been removed. At the time of the visits this drain was dry over much of its length but water appeared in it at a point close to where the channel of the other drainage line disappears.

The drain which runs parallel to Birmingham Road from the corner of Naven Boulevard is also of relevance in this survey as it indicates the hydrological regime on that side of the property. Although dry for much of its length at the time of the site visits, it is clear that it carries large flows at times. The banks and bed are eroded, and in places the underlying plinthite layer is

**Figure 1.** Distribution of the soil survey points on the Panorama Gardens site. Note the pipeline valve chamber and the ferricrete which indicate the position of the Birmingham Road drain.

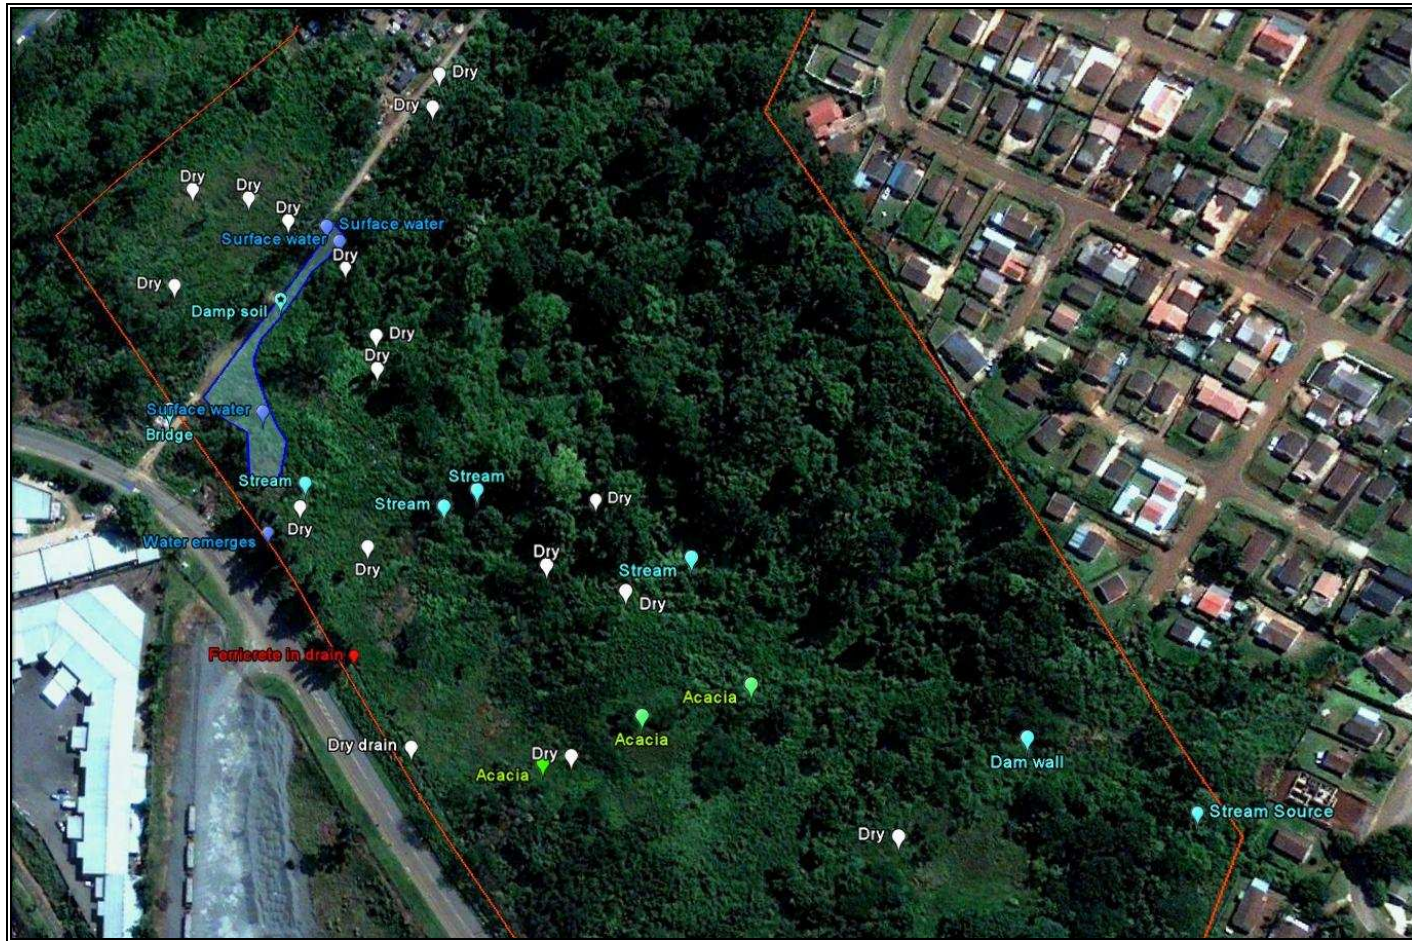
However, surface water, or recent evidence of surface water, was observed in an area close to the point at which the service track from Birmingham Road enters the property, and then for about 85 metres along the track towards the quarry. This water was underlain by heavy soils but the distribution of the soils was restricted to a strip along the eastern side of the track. By contrast the area between the track and the Baynes Spruit, even though it is largely in the 1 in 10 year floodplain (Terratest, 2010), showed neither any wet areas nor any signs of wetness in the soil. It is assumed that development in this area would be restricted due to the presence of the floodplain and so a buffer would incidentally be set in place.

On the basis of the observed stream flows it appears that the small stream which flows from the east side of the property is the primary source of water in the area near the service track. Once its excavated channel flattens out, the water diffuses over a wider area. It is unable to percolate away due to the underlying plinthite layer and so the soils in the area are seasonally saturated. This accounts for the appearance of the water in the drain from the pipeline valve chamber and also explains the observed damp conditions along the eastern side of the track. The track itself appears to be impermeable as it has, over the years, been regularly hardened with road material and so now acts as a “buried dam wall”. Such impermeability also explains the complete absence of wet conditions on the western side of the track.

**Figure 2.** Portion of the property showing the area along the stream and where wet/moist conditions were encountered. Survey sites are shown in the following colours: White = dry, Light blue = stream or damp conditions, Dark blue = surface water, Green = trees which require dry conditions. Also shown as a blue polygon is the area within which moist conditions were found.

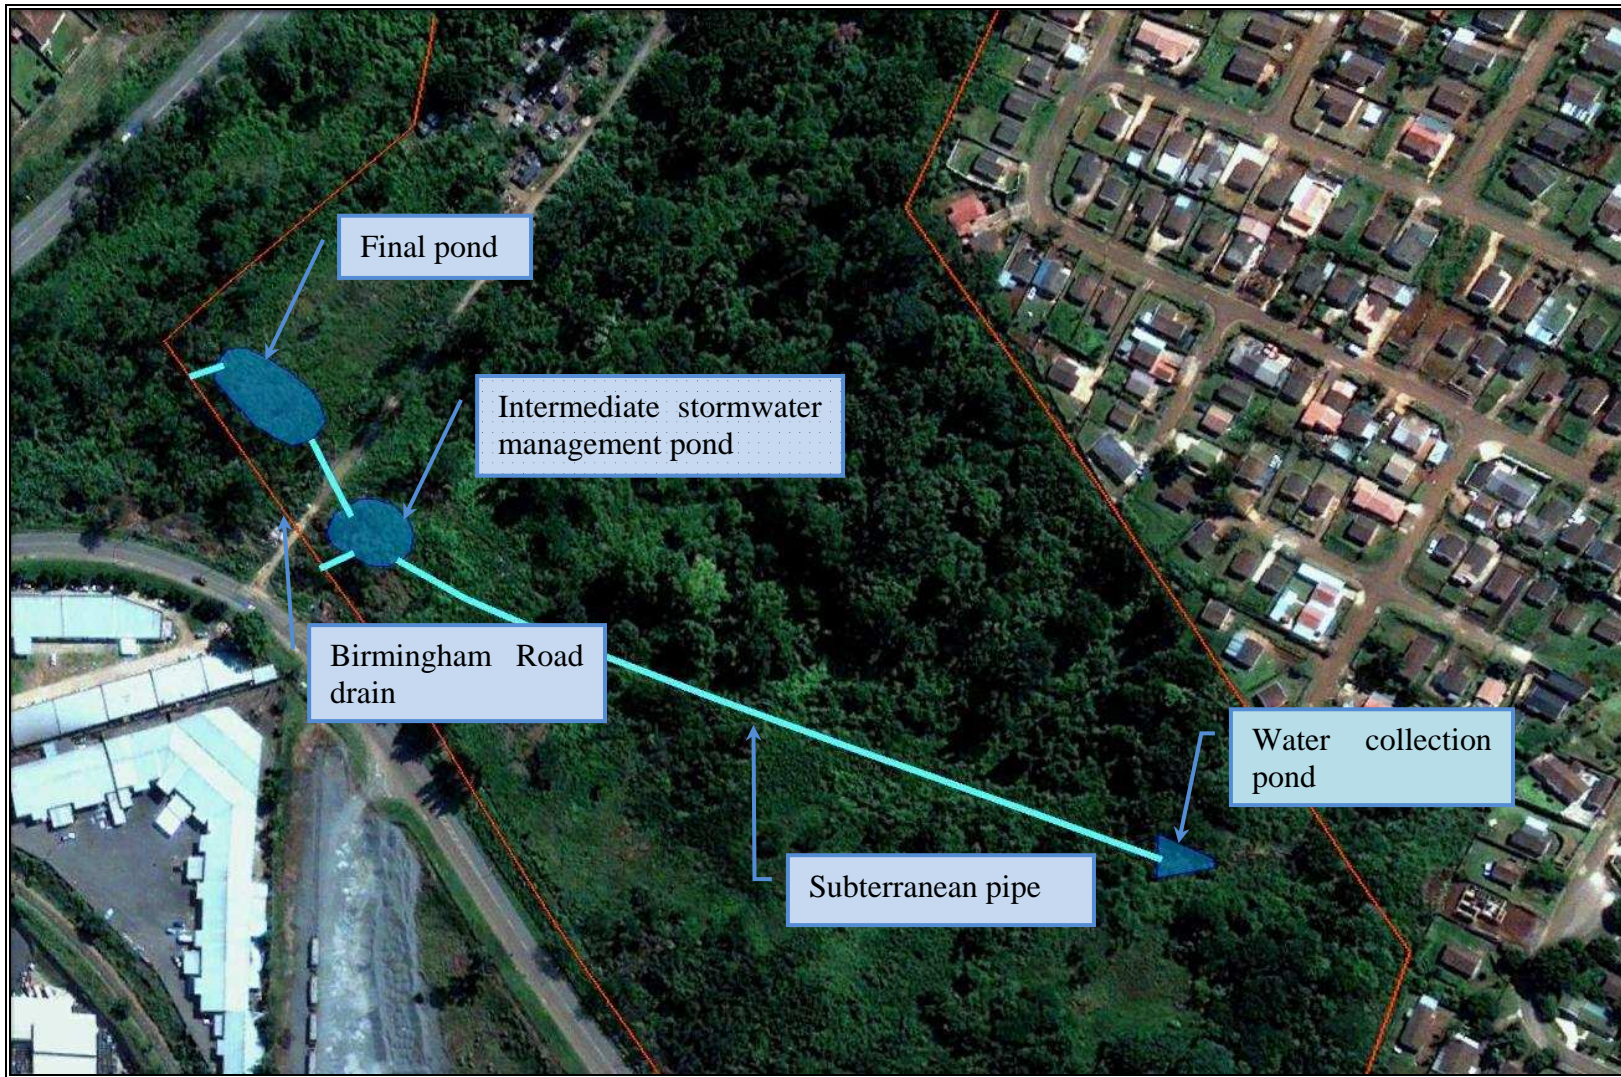
**Figure 3.** Schematic representation of water management on the Panorama Gardens site.

- At the upper end of the stream where the water emerges from the neighbouring properties, the existing small dam should be cleaned out and be repaired so as to form a small wetland. This wetland will act as a preliminary biological filter and some water purification may be expected before the water flows into the subterranean pipe.

- The pipe should, at its downstream end, discharge into a pond which may additionally serve as a stormwater flow attenuation pond. This pond must be east of the service track and the water should be no more than a metre deep in the dry season. Growth of reeds, sedges, and the like should be encouraged so as to act as a further biological filter. There should be two outlets with the lower one being for the release of normal flows, and a second, higher outlet which discharges directly into the Birmingham Road drain. The latter outlet will cope with stormwater flows and will also serve to protect a further downstream pond.

- The low flow outlet from the second pond should be screened and should have a flap valve, or similar, so that it is closed off if the pond is filled by incoming storm water. The flow from this outlet must pass under the service track/road and into a second and larger pond which may be developed as a water feature with a park-like area around it. Suitable trees may be planted around it and reed beds would serve to both attract birds and to further purify the water. Outlet from this pond should pass into the Birmingham Road drain and then on into the Baynes Spruit. The above proposals are shown conceptually in Figure 3.
